T3 Syncro Pop-Top

a new lease...

Story & Technical Peter Coe

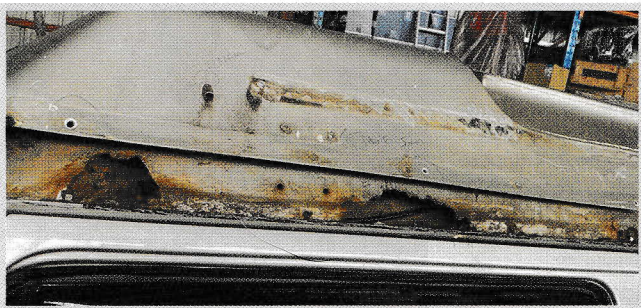
Matt lifted the pop-top and called me down to have a look. It was not good at all. Where I thought there was one hole, there were in fact three substantial holes and rust all the way down into the passenger side A-pillar and along the rain channel. Water had been getting in for some time and had caused considerable damage. Luckily the rust had not gone too far to the rear of the vehicle.

The damage had been caused by a previous owner pop riveting along the passenger side of the pop-top base through the fibreglass into the body of the roof of the van. The rivets were aluminium and of course through a process of electrolysis had caused the rust problem.

The pop-top was attached at the factory, with rivets on the top and you can see from the photo where these rivets were located. There was no rust around any of these rivets because water could not get up to this position.

There was no option but to commission a full refurbishment of the pop-top including repairing all the holes and damage to the pop-top, removing all the rusted metal, welding in new sections and rebuilding the rusted-out rain channel. Matt put in extra ribs in the pop-top and did a full repaint. In the process Matt recommended some changes to how the pop-top was attached to the van. As there are now modern adhesives that are well suited to this work, Matt recommended that the base of the pop-top be glued to the metal of the van and in the process he put in a silicone seal around the whole pop-top so that there is no chance that rain water can get into the van. I also had wiring put in for a ceiling light.

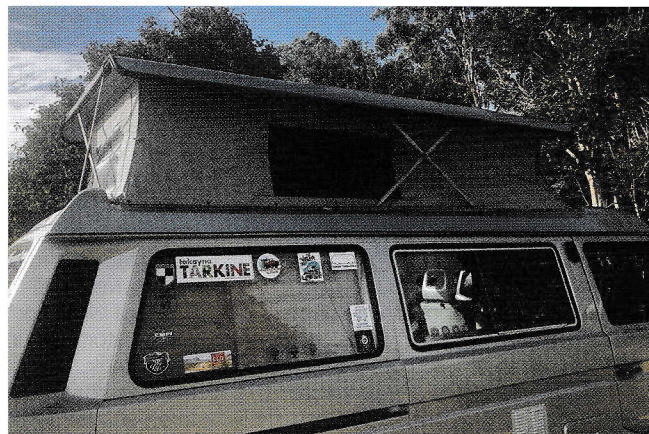
The end result is quite stunning and I am very pleased with the quality of the work and the excellent workmanship of Matt and the upholsterer in carrying out this very difficult job. The photos show the results of this most difficult and costly project, but I am very pleased that the van is now waterproof as much as possible and we can look forward to keeping dry while exploring more of this wonderful country in a VW classic van.

When finished I had new canvas installed by a firm in Coffs Harbour and they did a very professional job as you can see. The next step was the headliner. I used a very good tradesman in Port Macquarie who specialises in automobile and marine upholstery. We removed the pop-top and I put in a 3mm plywood ceiling which was then covered in new fabric. Headlining was done to the rest of the van and I replaced the old sun visors with new ones. I also installed new lights in the side and ceiling of the cabin.
